Fractures of beam-to-column web moment connections, March 1979

FRACTURES OF BEAM-TO-COLUMN WEB
MOMENT CONNECTIONS

March 1979

Supplemental tests and analyses were made to determine the cause of fractures in two beam-to-column web moment connections. Fractures had occurred in tension flange connection plates during static monotonic bending tests of subassemblages containing the connections.

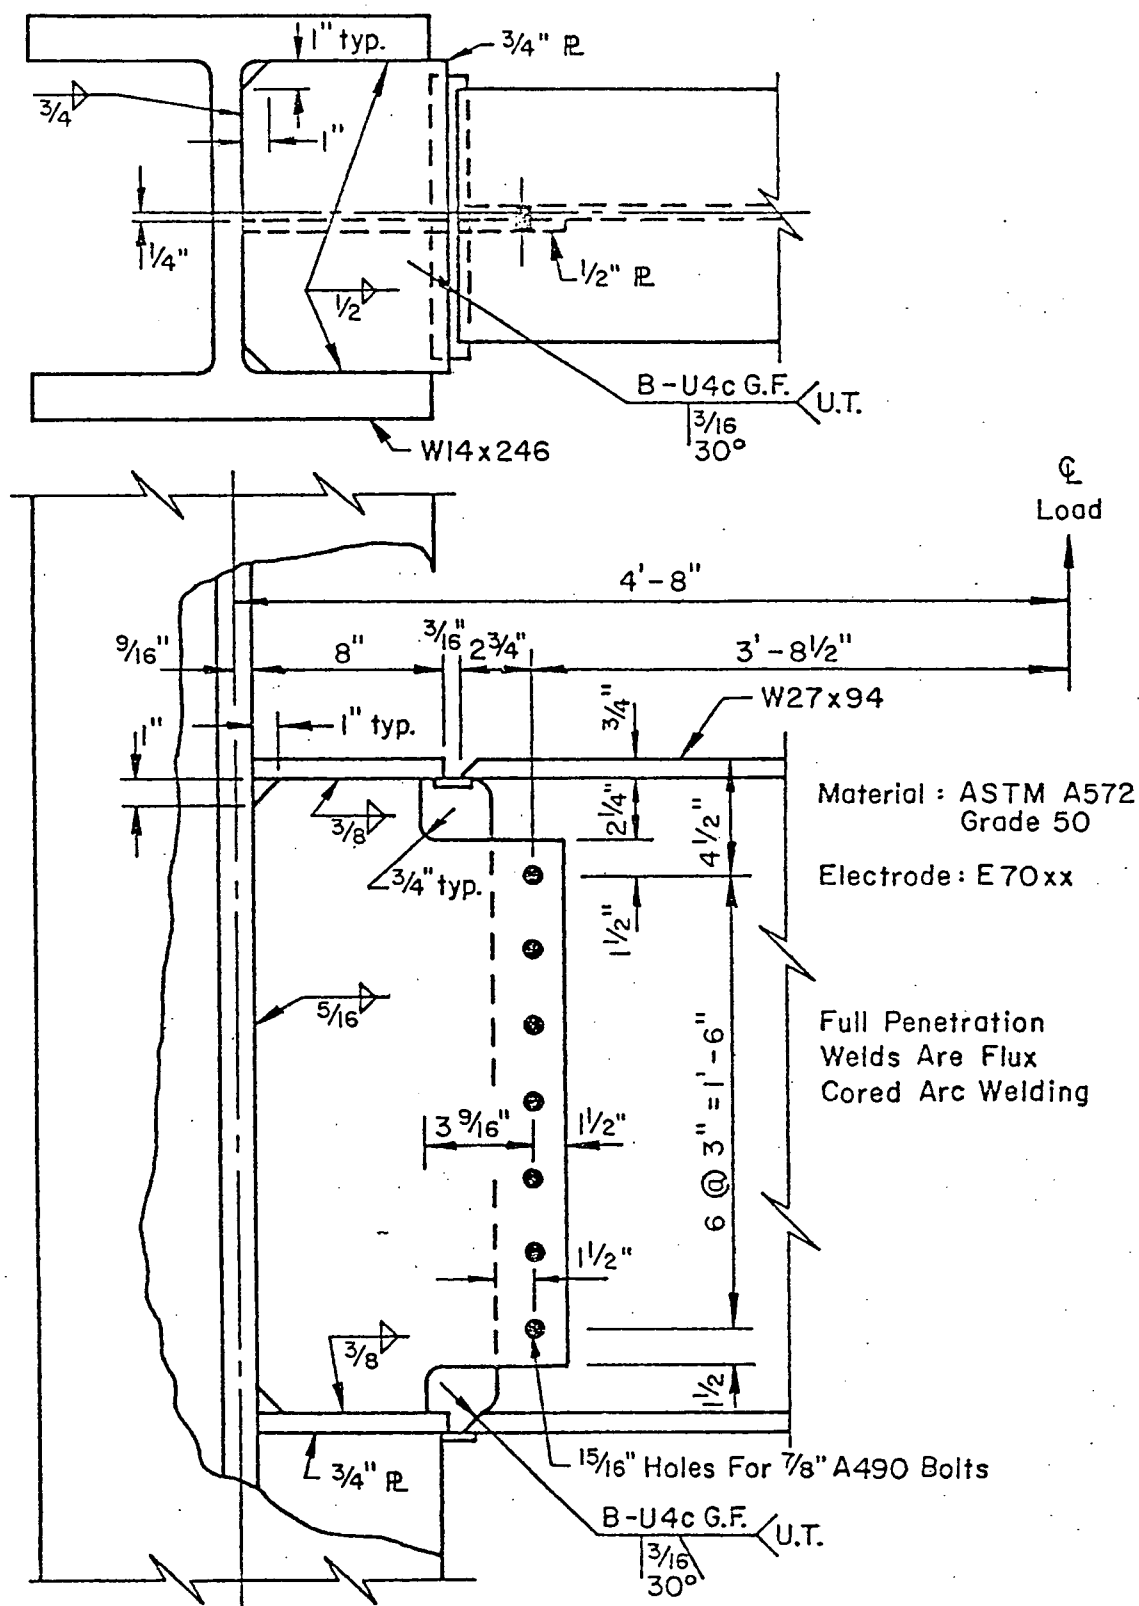
Fig. 1 Details of Connection 14-1

A sketch of the fabrication drawing of Connection 14-1 is given in Fig. 1. This connection was planned to provide a field bolted connection of the beam web to a shear plate welded to the column web. Field welded groove welds were planned to connect the beam flanges to connection plates welded to the column web and flanges and to the shear plates.

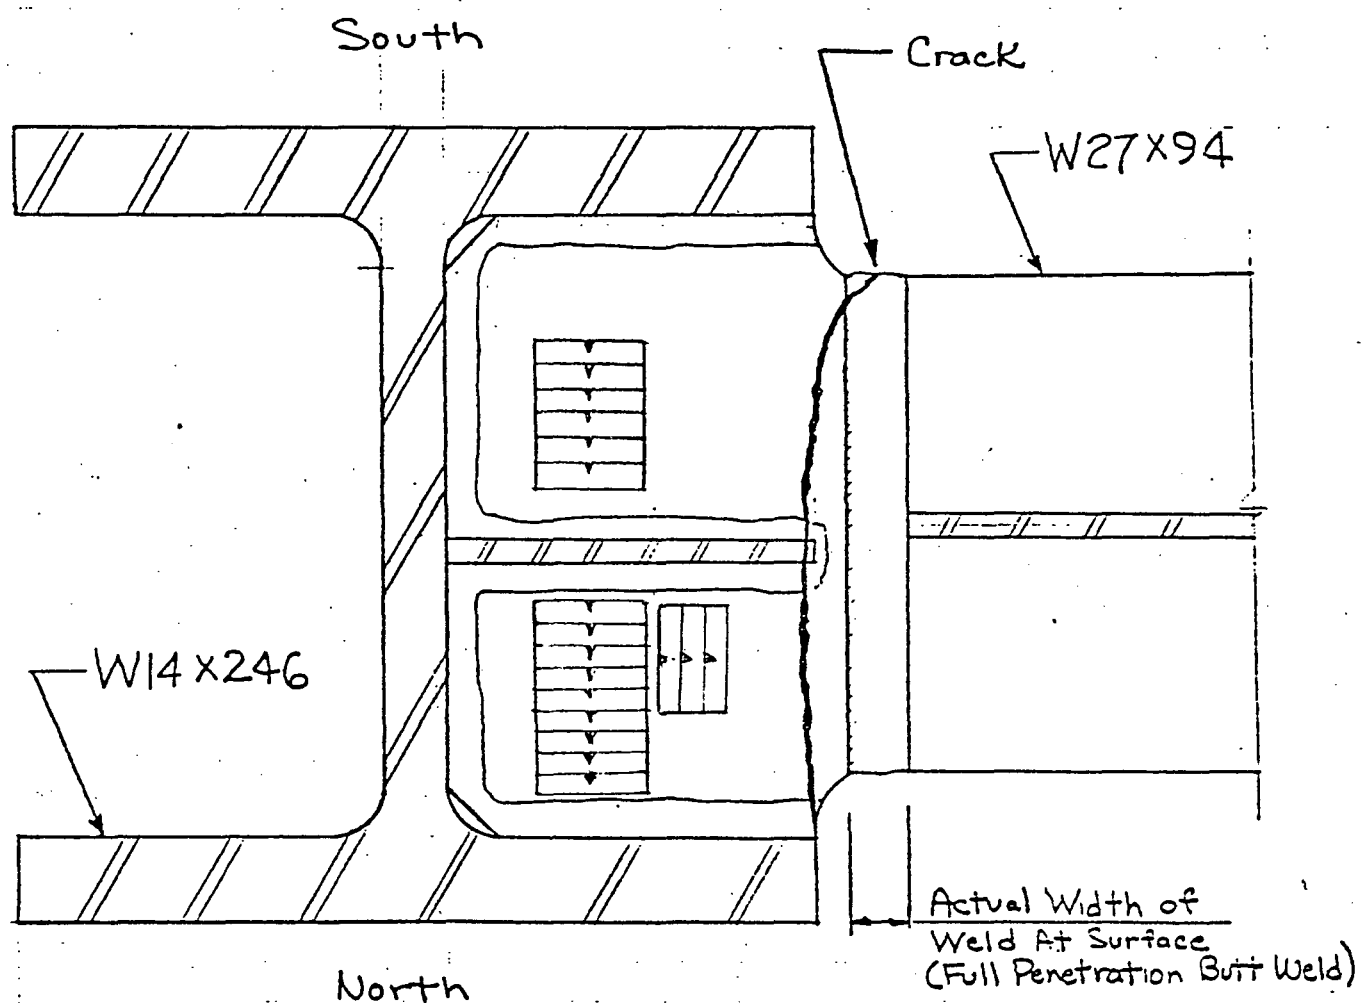
Fig. 3 Failure Location in Test 14-1

Figure 3 shows the location and extent of the crack which occurred during the connection test. Also shown is a smooth radius gratuitously formed by the fabricator in the connection plate between the point where the column flange ends and the beam flange begins. This detail may be compared with the squared off connection plate backing bar and beam flange of Fig. 1.

The fracture of Connection 14-1 initiated at the edge of the butt weld joining the beam tension flange to the connection plate. The point of crack initiation is indicated by the point of the arrow labelled "crack" in Fig. 3. The metallurgist noted that this point would have a strain concentration due to the reduction in plate width at the end of the radius. He also noted that weld irregularities could have concentrated to the strain concentration. The fracture was predominantly brittle in nature although there is evidence of several crack arrests which indicates some ductility in the region. There is no evidence of defects on the fracture which could have contributed to the failure.

The metallurgist concluded that this connection failed in a brittle manner due to the large applied tensile strain which was concentrated at the design detail. The defects present in the weldment were not identified as the primary cause.

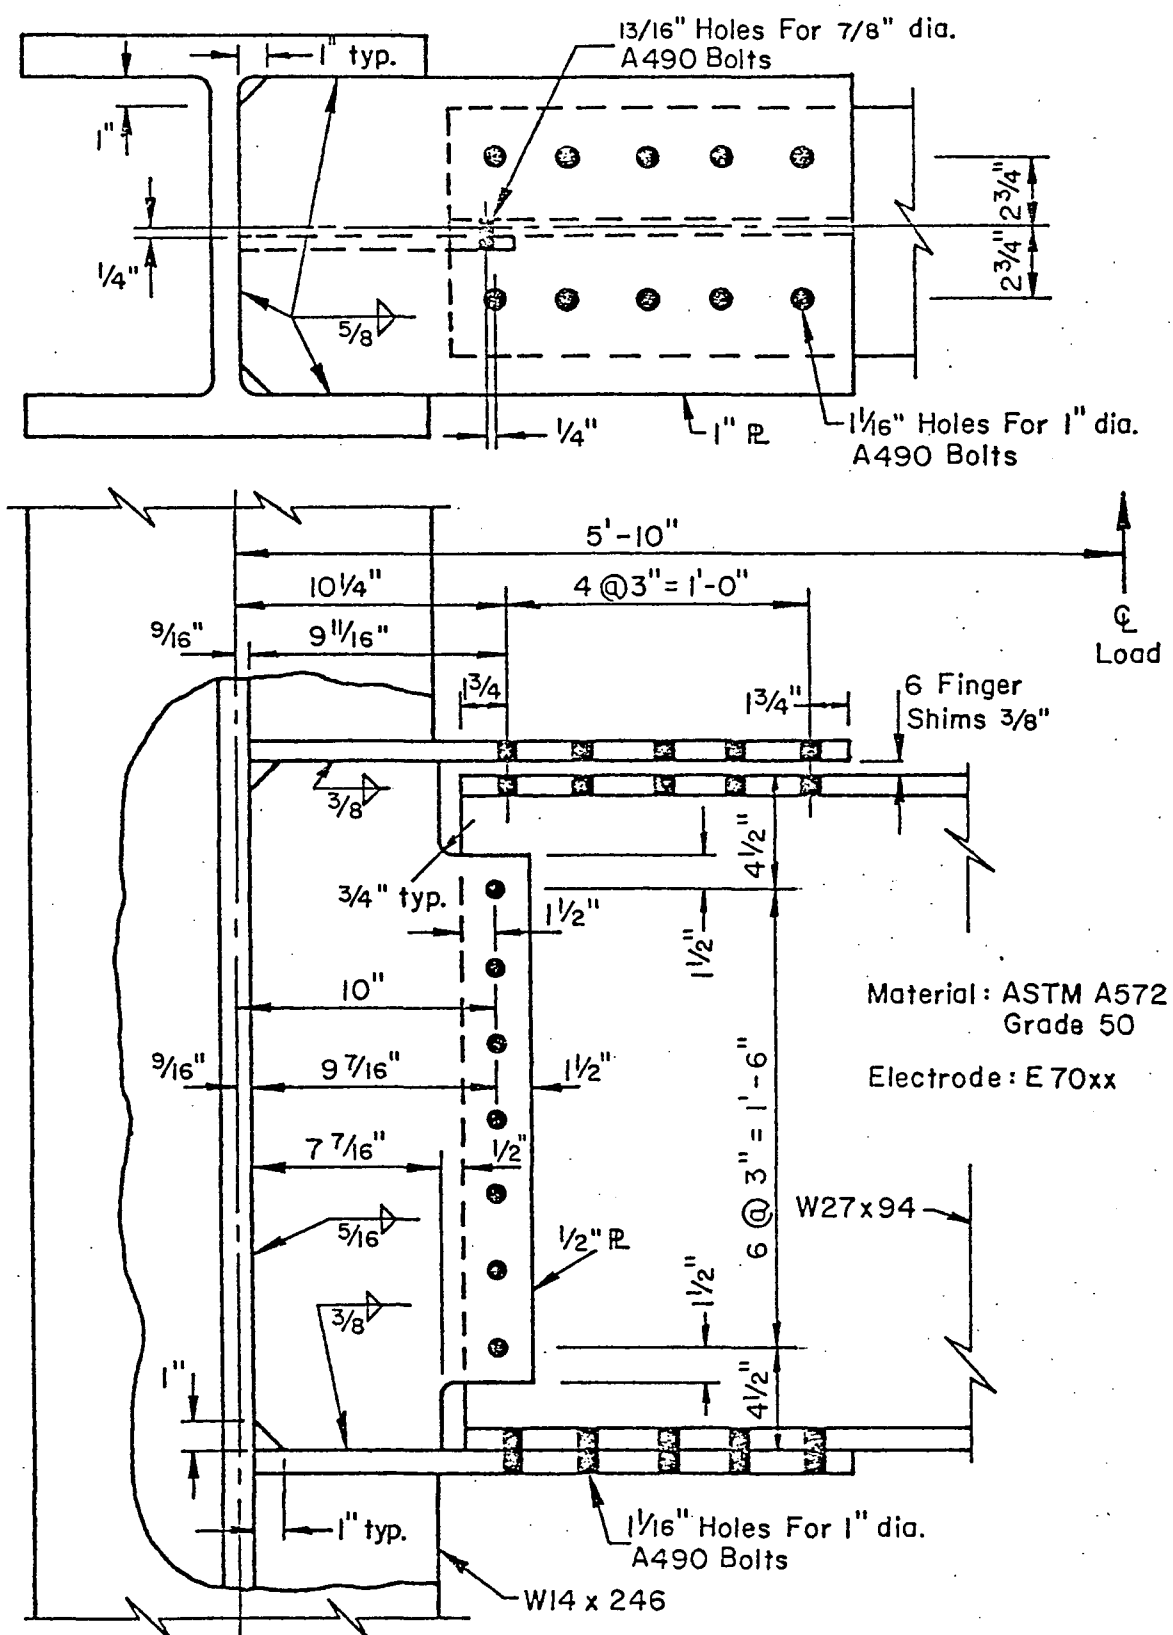
Fig. 4 Details of Connection 14-3

Fabrication details of connection 14-3 are given in Fig. 4. This connection was planned for field bolting of both flanges and web of the beam to flange plates and web plates shop welded to the column.

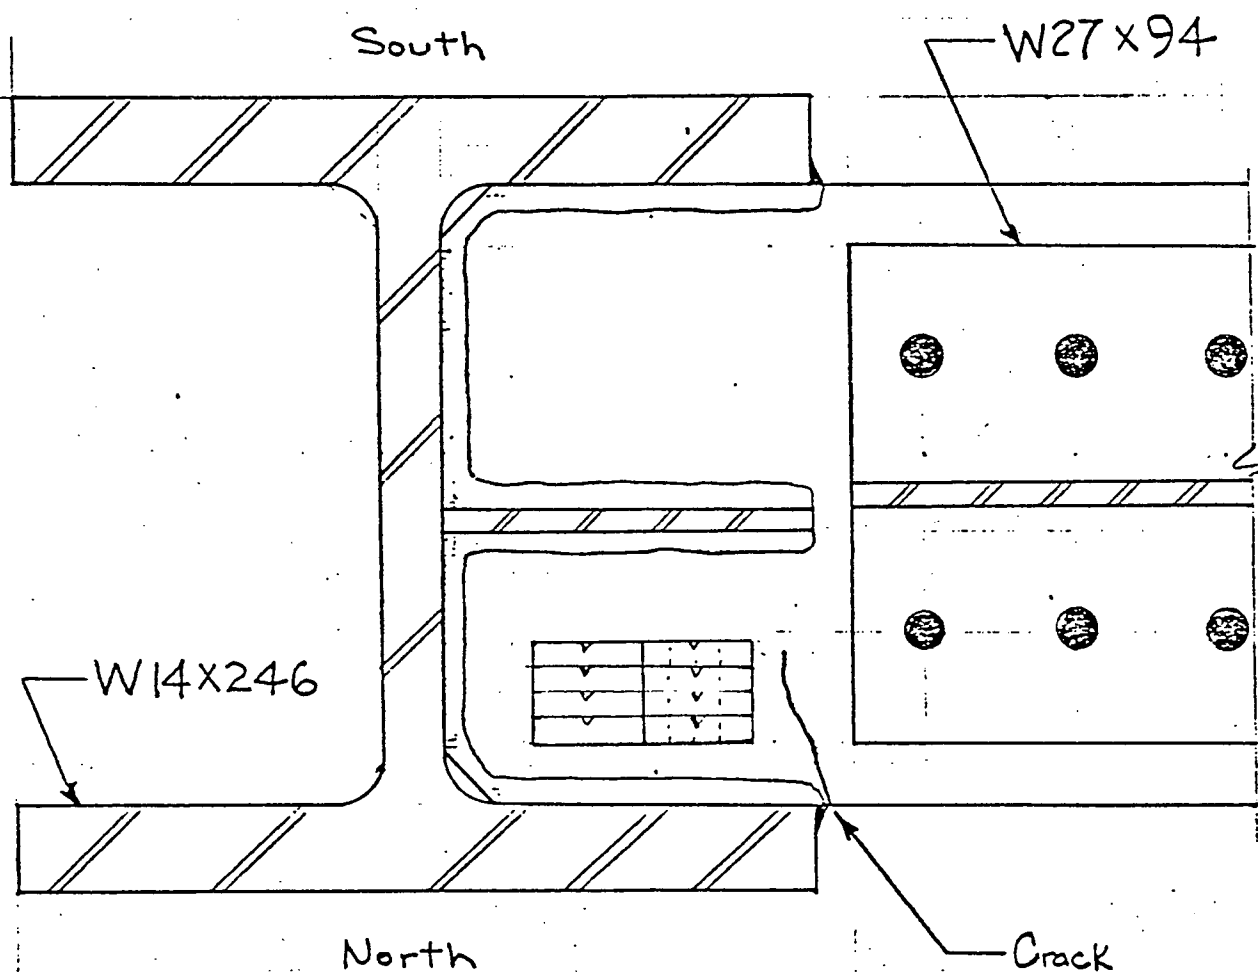
Fig. 6 Failure Location of Test 14-3

The path of the failure crack is plotted in Fig. 6. The figure also shows the location of cosmetic weld passes provided along the thickness of the connection plate at the tips of the column flanges.

The fracture of Connection 14-3 initiated at the end of the welding joining the tension flange connection plate to the column flange. The fracture propagated across the tension plate normal to the applied tensile strain. The initiation site appears to be at a cosmetic welding pass between the edge of the column flange and the side of the connection plate. The point of crack initiation is indicated by the arrow labelled "crack" in Fig. 6. The fracture was predominantly brittle, but shear lips are present indicating some ductility in the connection plate. There is no evidence of any defects on the fracture surface. (Note: The "cosmetic welding pass" might also be called a seal weld.)

The metallurgist concluded that Connection 14-3 failed when a large amount of strain was applied and was concentrated at a design detail (the edge of the column flange and tension plate) which was made worse by the use of a cosmetic edge welding pass.

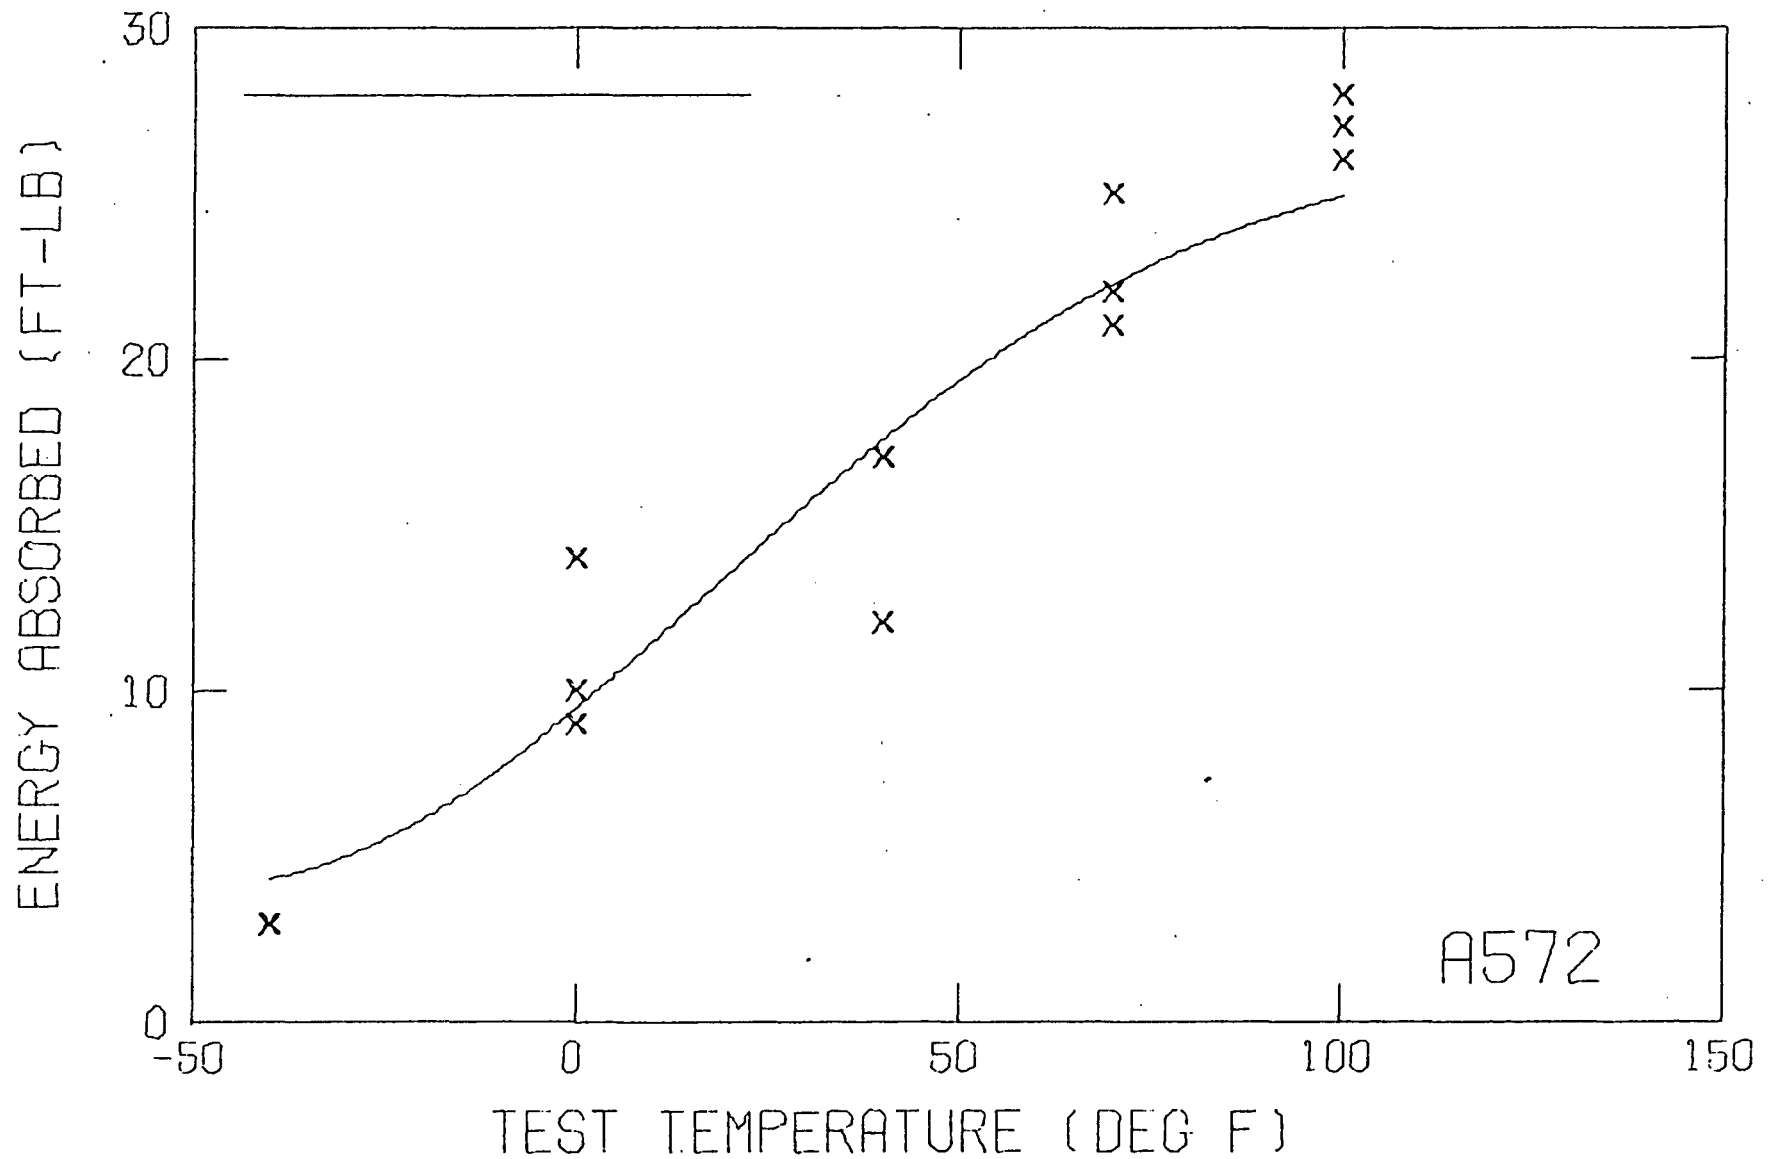
Fig. 7 Charpy Test Results for Connection 14-1

The fifteen TL specimens of Connection 14-1 were tested as planned, 3 each at temperatures of -40°F , 0 , $+40$, $+70$, and $+100$. Since 40°F appeared to be the temperature at which 15 ft-lb of energy was absorbed, the three LT specimens were tested at $+40^{\circ}\text{F}$. The test results were evaluated using a Metallurgy Department computer program which averages, curve fits, and plots the results. The resulting plot is given in Fig. 7 and the numerical results are given in Table 1. Based on an impact energy criterion, the steel was able to absorb 15 ft-lb at a temperature of 27.0°F . This is better than the AASHTO fracture-toughness specifications for A572 steel to be used in Zone 2 with minimum service temperature from -1 to -30°F (15 ft-lb at 40 F).

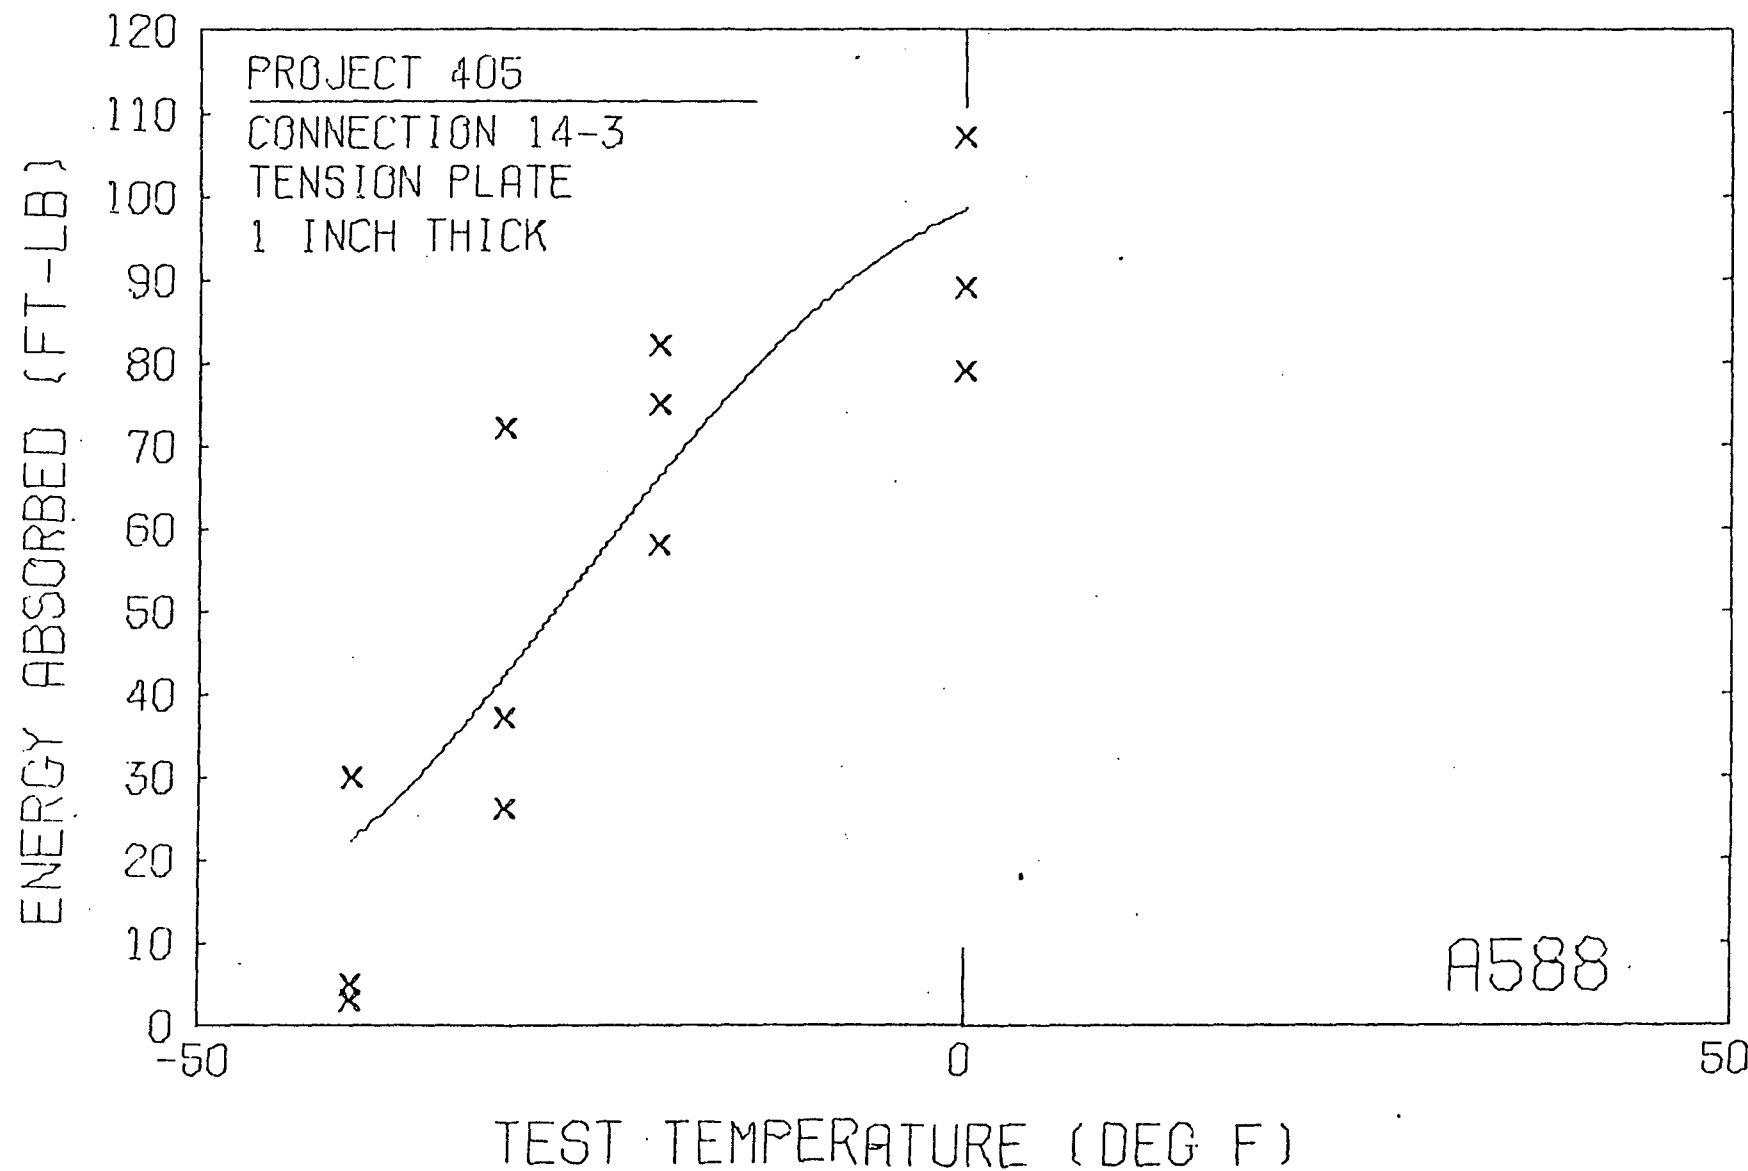
Fig. 8 Charpy Test Results for Connection 14-3

-40 F resulting in values averaging less than 15 ft-lb. Henceforth, three specimens were tested at -30°F and three at -20°F. The test results are plotted in Fig. 8 and the numerical results are given in Table 2. Based on the impact energy criterion, the steel was able to absorb 16 ft-lb at a temperature of -49°F. This is better than the AASHTO fracture toughness specifications for A588 steel to be used under the most severe Zone 3 requirements with minimum service temperature from -31 to -60°F (15 ft-lb at 10°F).
